**International Journal  
of Earth Sciences  
and Engineering**

April 2015, P.P.440-446

ISSN 0974-5904, Volume 08, No. 02

## Rehabilitation of Non-Ductile Exterior Beam-Column Joints by RC Jackets with U-Bars and Collar Bars

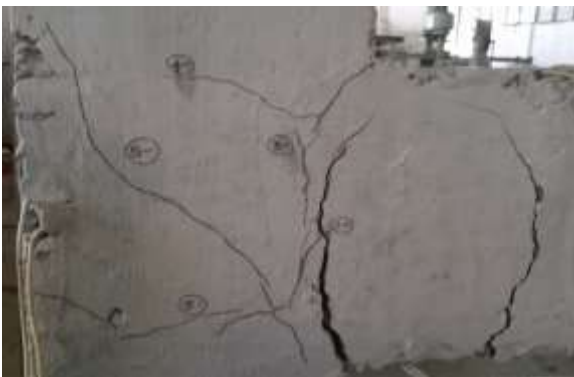
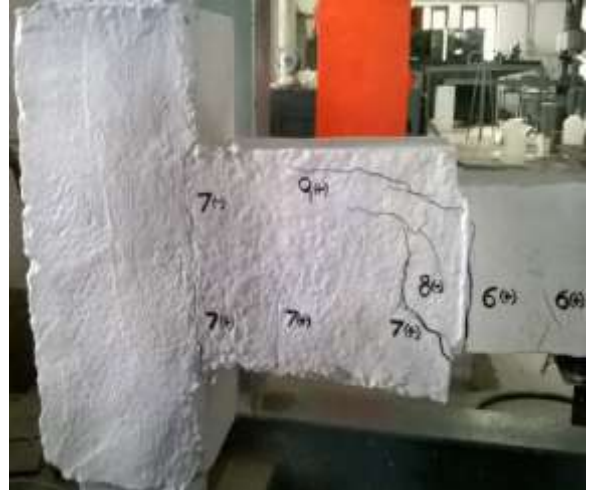
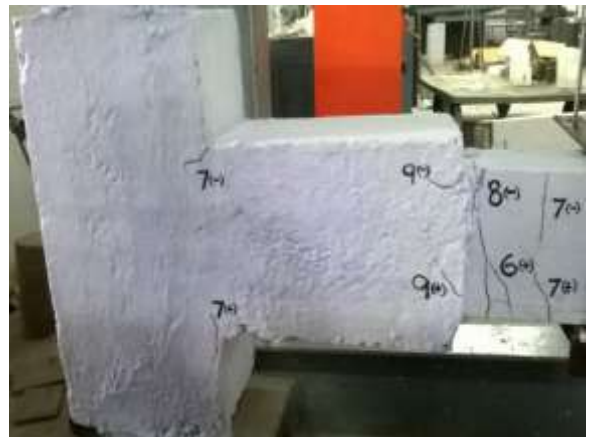
The cracking patterns of the tested specimens are shown in Fig.7 For the control specimens, initial diagonal hairline crack on the joint region occurred at the third loading cycle when the load reached 6 kN in upward direction. A major diagonal crack was developed at the beam-column interface which is a clear indication of brittle joint shear failure. In actual structures this can result in brittle shear failures which are highly catastrophic in nature. The cracking of the beam region occurred in the subsequent cycles and the specimen failed at an ultimate load of 9 kN. Though a partial beam hinging mechanism was observed in this case, the propagation of a large number of cracks to the column region and the formation of diagonal cracks at the joint region makes it a shear mode of failure.

For the RE-CJ specimens, first crack was observed on the fifth cycle of loading in the downward direction at a

load of 10 kN. Due to the absence of additional reinforcements, a large number of cracks were observed in the jacket region. There were cracks propagating to the joint region of the jacket signifying the inadequacy of the jacketing scheme to resist joint shear failure. Though the ultimate failure occurred beyond the jacket portion, the excessive cracking of the joint region as well as the remaining portion of the jacket signified the need for additional reinforcement. The RE-NCJ 1 specimens exhibited first crack on the seventh cycle on loading in the upward direction, at a load of 14 kN. Though there were a few cracks in the jacket, the provision of diagonal collar bars completely prevented the propagation of cracks to the joint region, thereby improving the shear strength of the specimens. The delayed crack formation as compared to the RE-CJ specimens clearly signified an improvement in stiffness of RE-NCJ 1. RE-NCJ 2 specimens showed reduced number of cracks compared to RE-CJ. The provision of U-bars improved the stiffness by a great deal and the jacket portion was devoid of any serious cracking. Though there were cracks initiated near to the joint region, their propagation was properly arrested by the U-bars. Though all the jacketed schemes failed by breaking of the beam beyond the jacket region, the better cracking behaviour of RE-NCJ 2 makes it an attractive option for rehabilitating actual structures.

**Figure 7** Crack patterns for tested specimens
